Splice Damage Detection—Example

Complete Conveyor
Solutions...

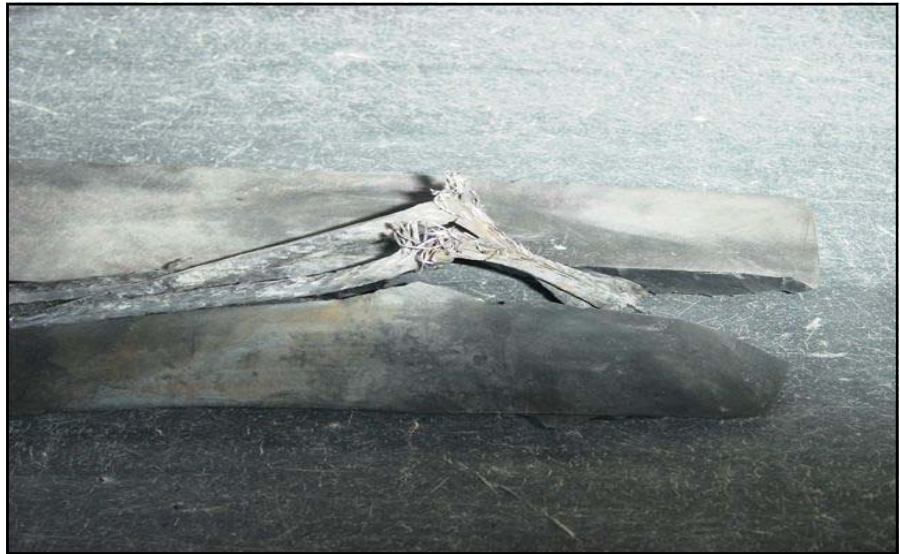
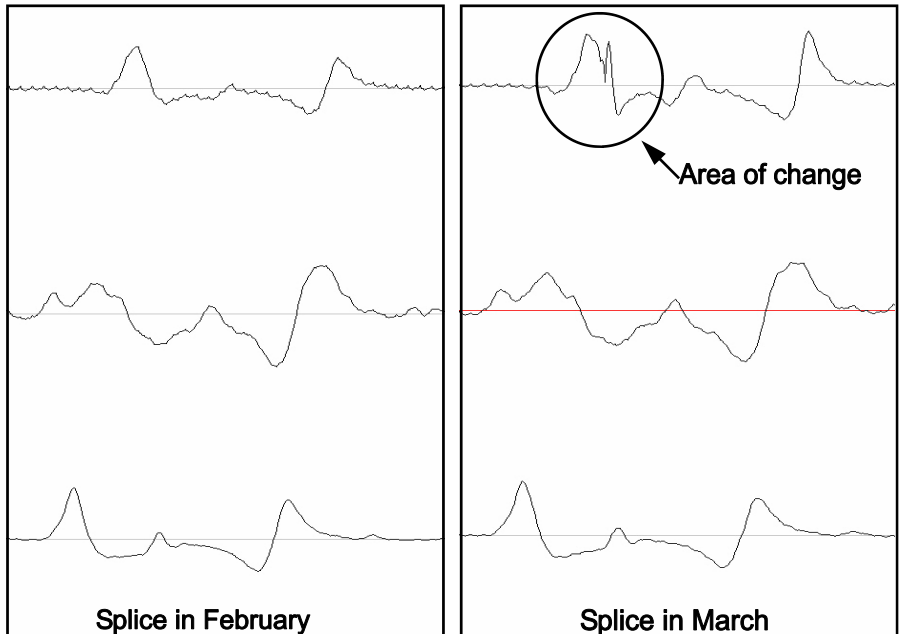
Above is shown a magnetic splice signature for one splice in February and in March. A change to an area in the leading left of the splice was noted during the March scan. Onsite inspections revealed that two cords had looped out of the splice and had broken whilst a third cord was damaged. Repairs were able to be quickly made to
